**Test Report Number: 103439 Issue 1**

**Test Sample(s) Description:** TRNC[G] Antenna Range  
TRNM[G] Antenna Range

## 1 Introduction

This report details the environmental testing carried out on one TRNC[G] Antenna Range Antenna and one TRNM[G] Antenna Range Antenna, as supplied by Panorama Antennas Ltd.

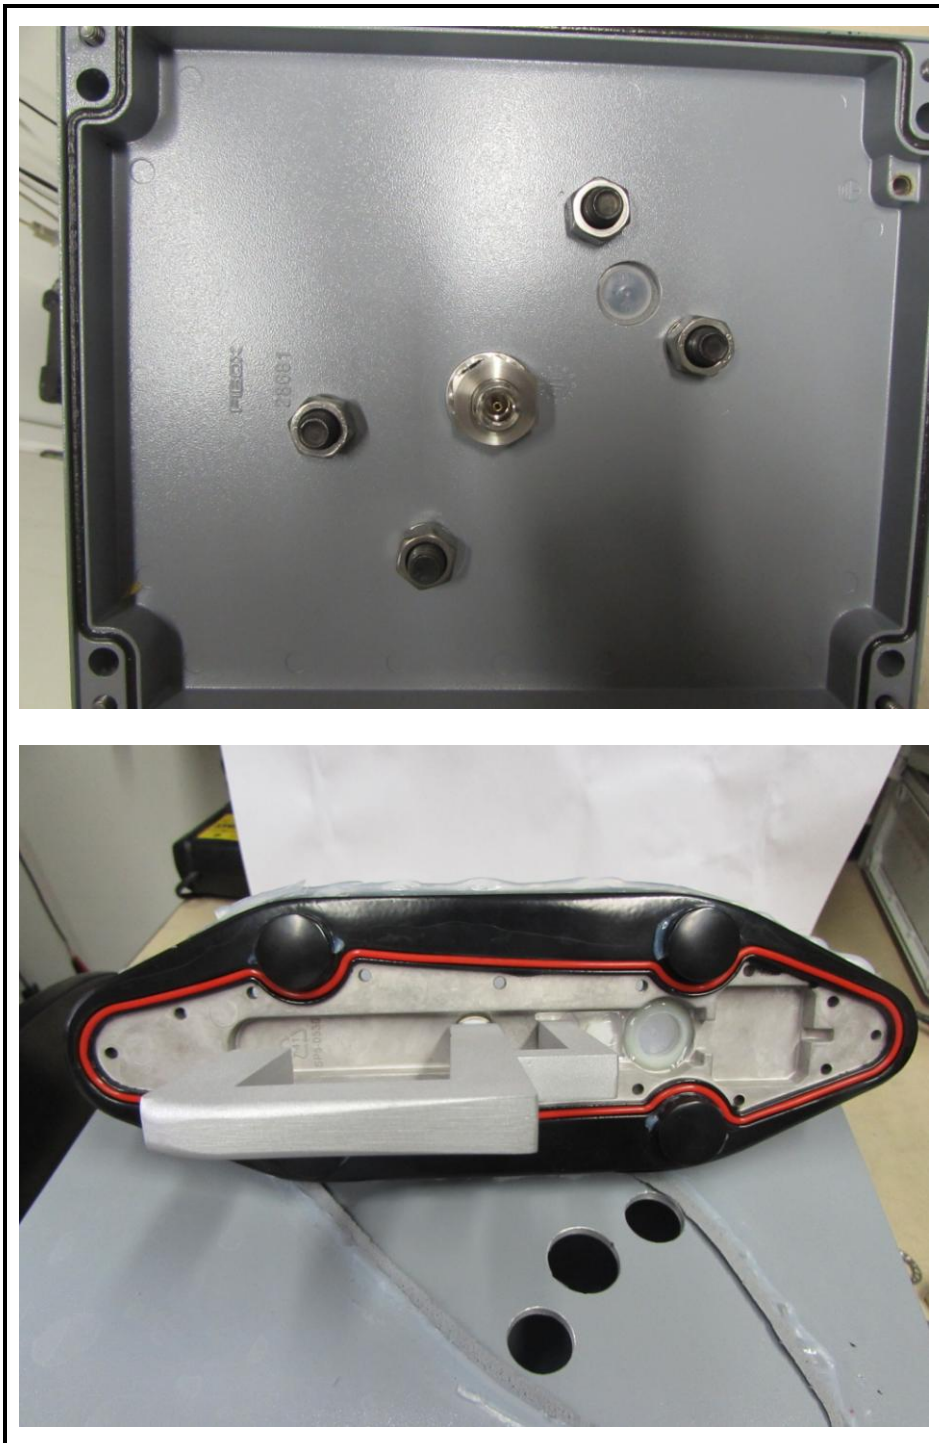
**Figure 2: Post Test Photos – IPx9K Water Ingress TRNC[G]**

On completion of the IPx9K test of the TRNC[G] Antenna Range Antenna, no signs of water ingress were observed within the case or the ABS enclosure.

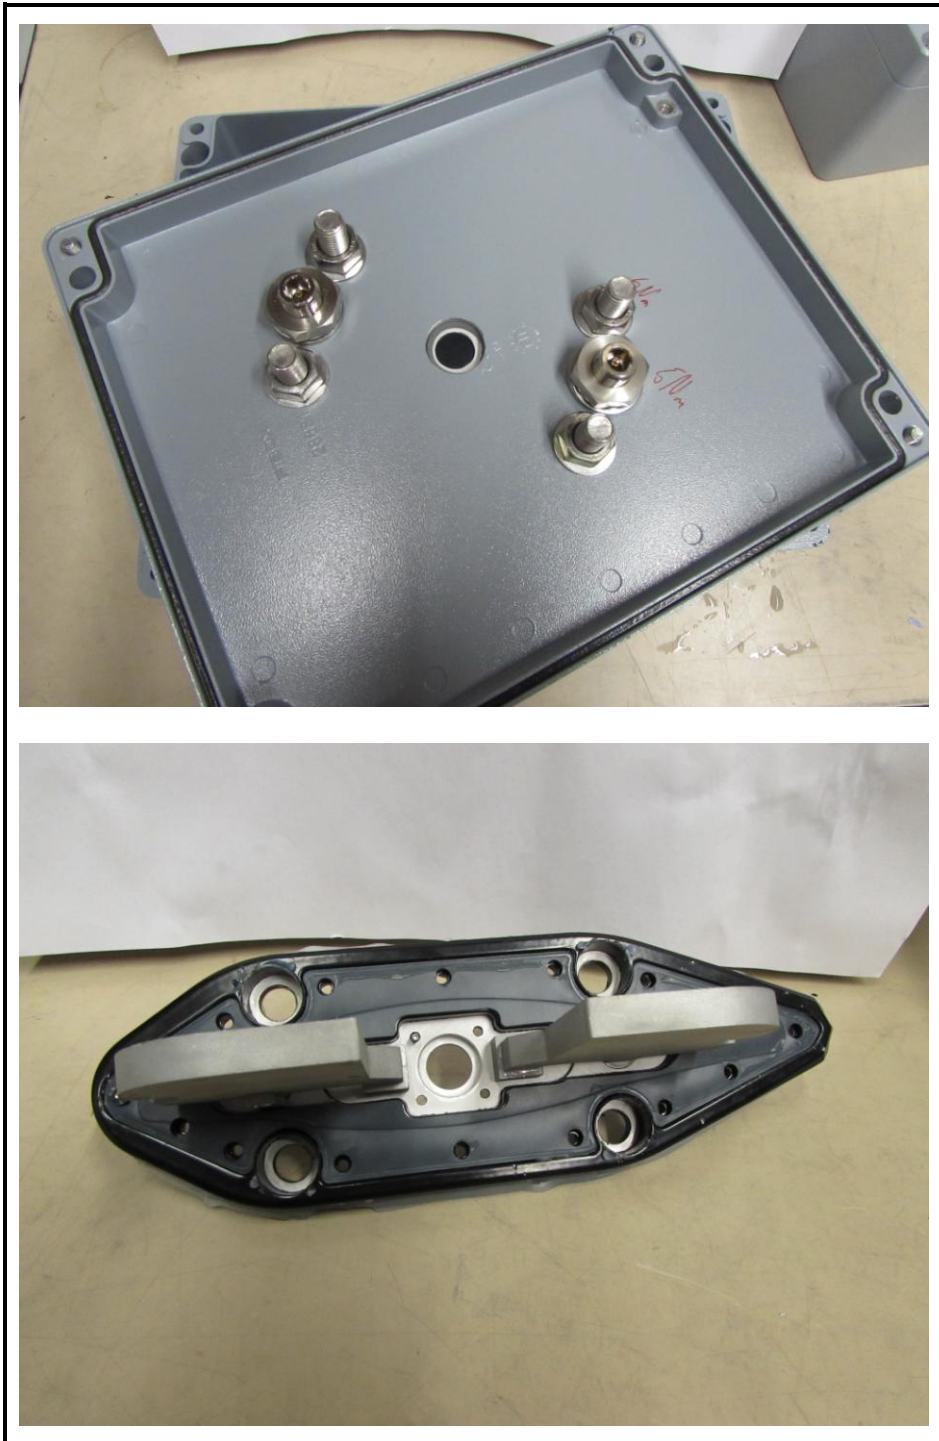
**Figure 3: Post Test Photos – IPx9K Water Ingress TRNM[G]**

On completion of the IPx9K test of the TRNM[G] Antenna Range Antenna, no signs of water ingress were observed within the case or the ABS enclosure.
